Chester St Peter – Window repairs

Repair of stained glass windows at St Peter's Church as per detailed schedule

Recclesia Stained Glass

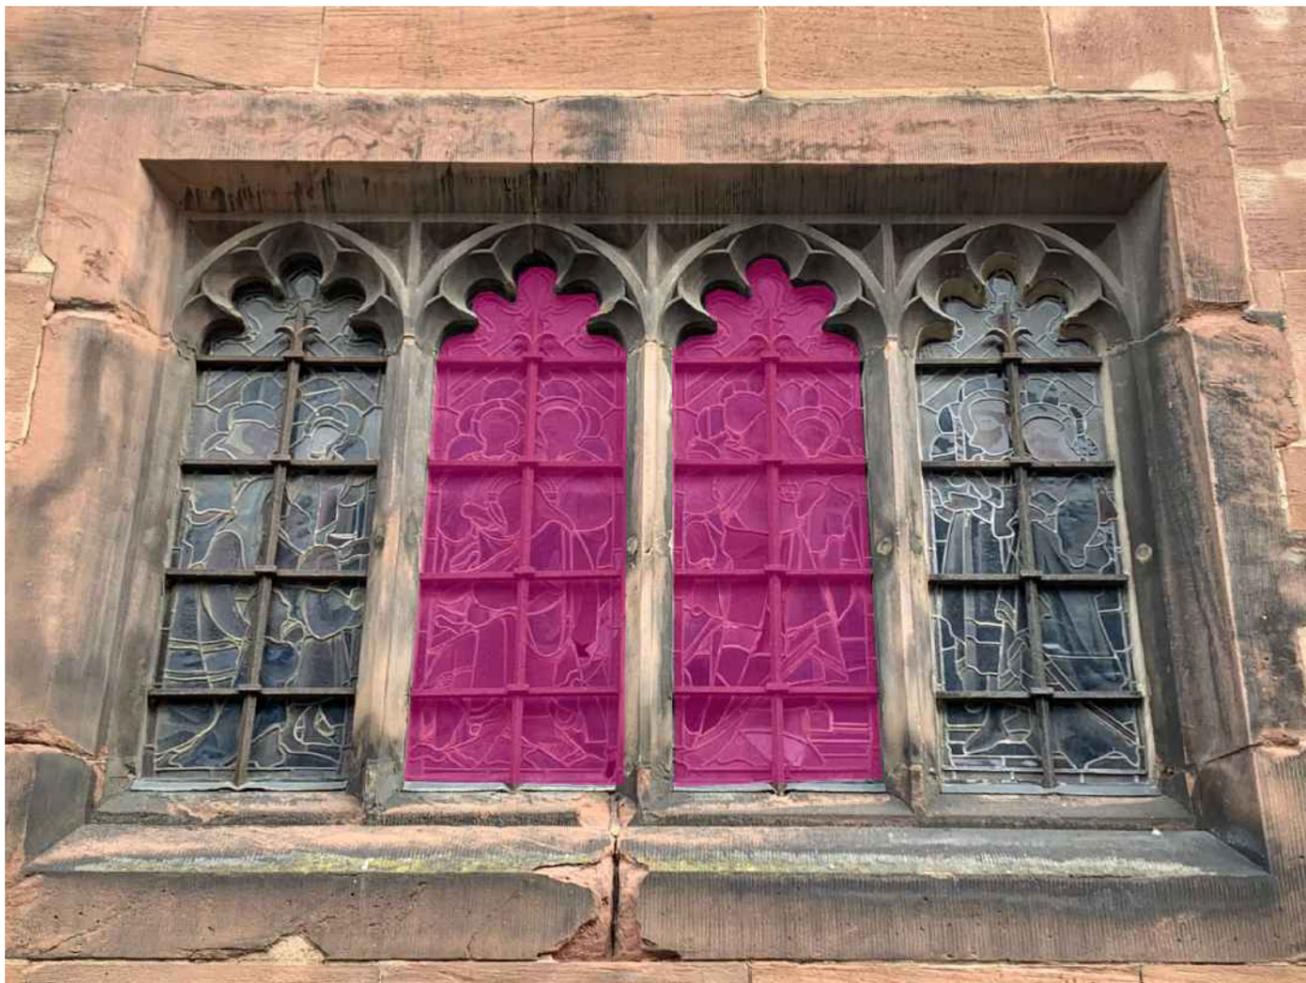
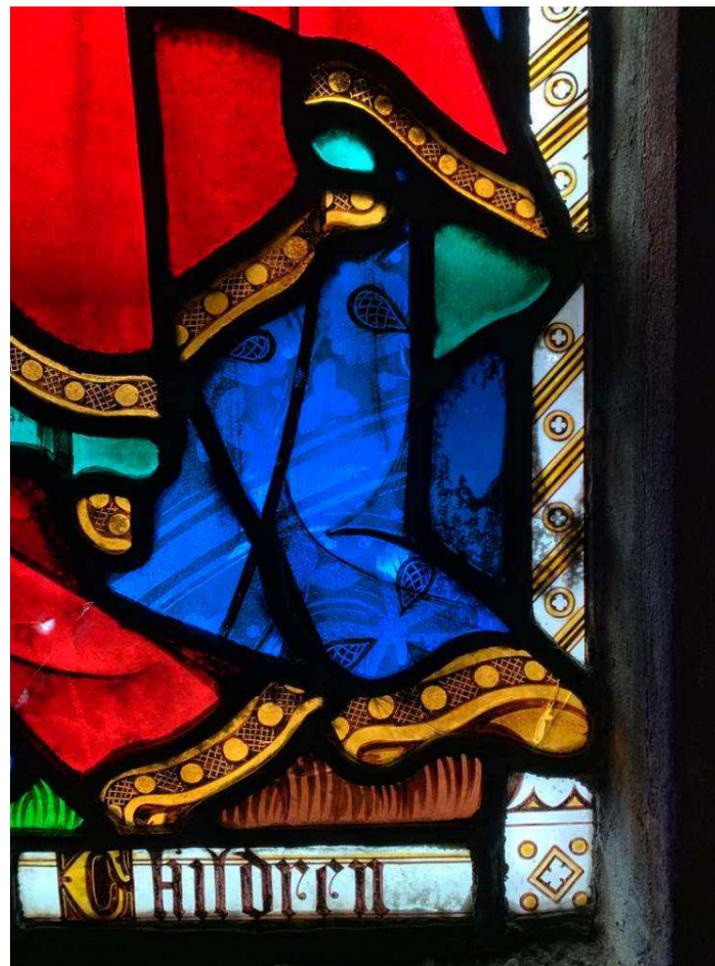
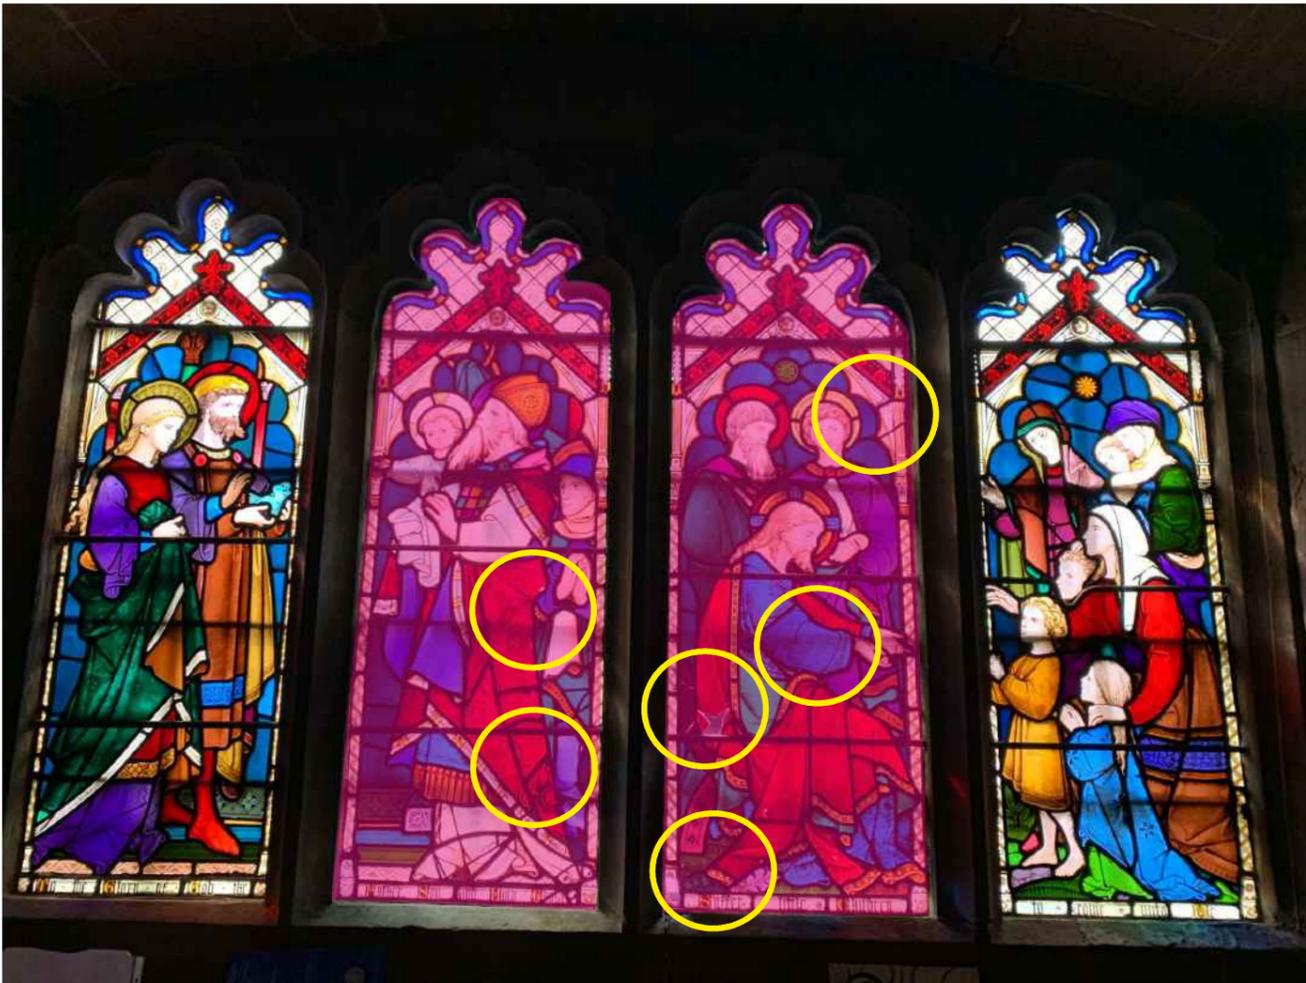
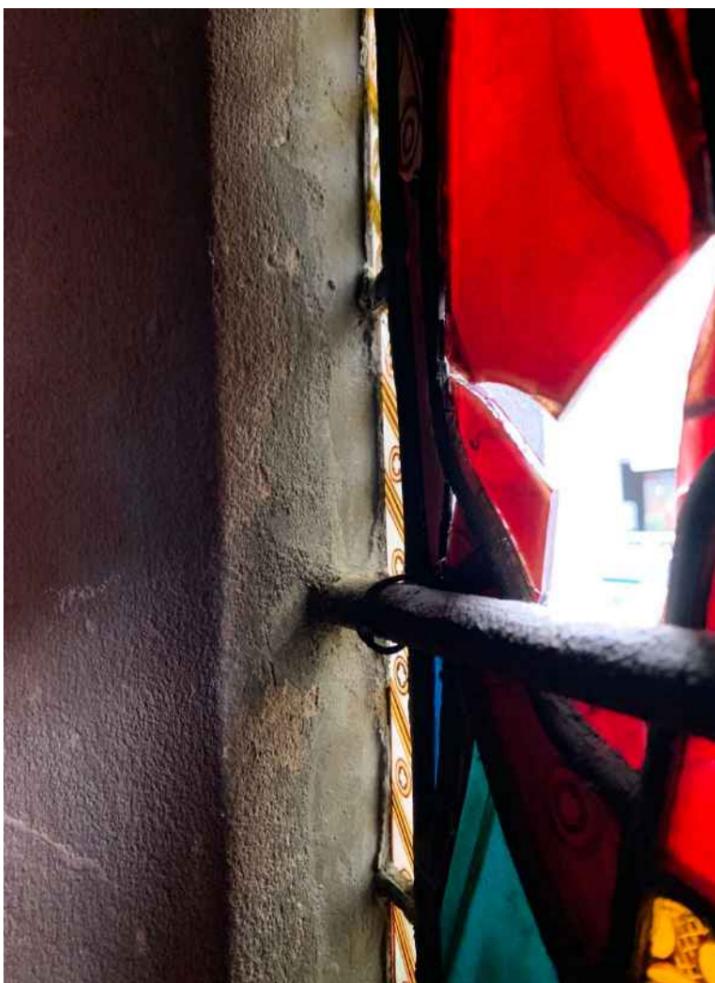
- REMOVE & REPAIR LANCET
- AREAS OF IMPACT

- 1 - External View
- 2 - Internal View
- 3 - Typical example of damaged leadwork and broken glass
- 4 - Typical example of damaged leadwork and broken glass

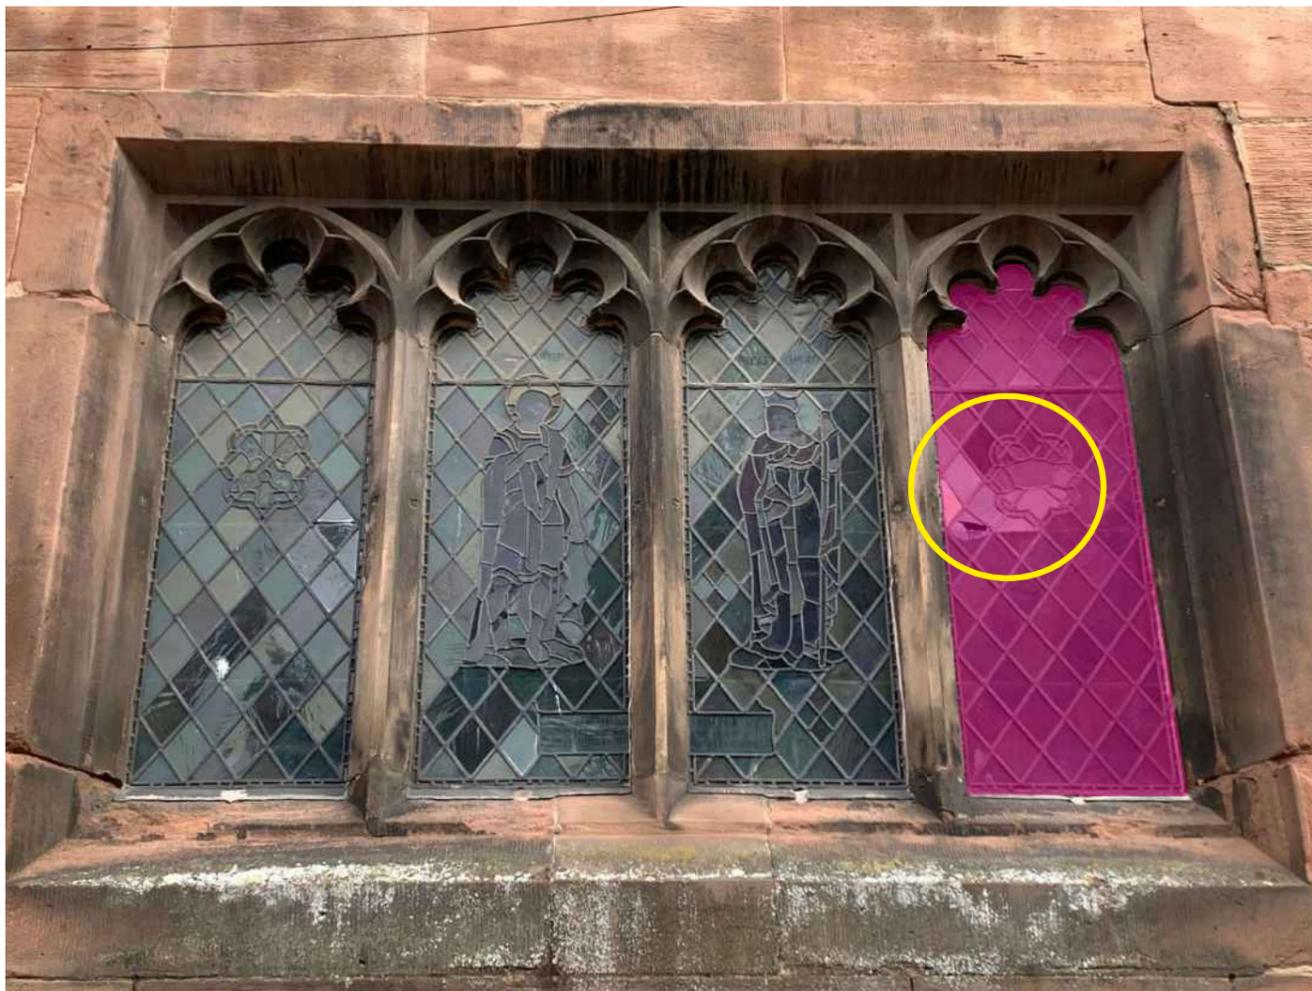
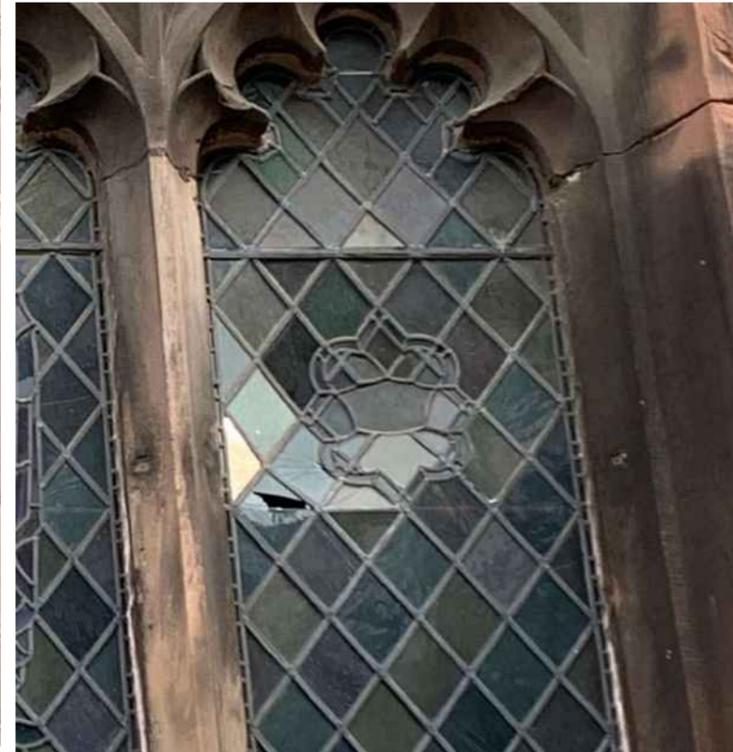
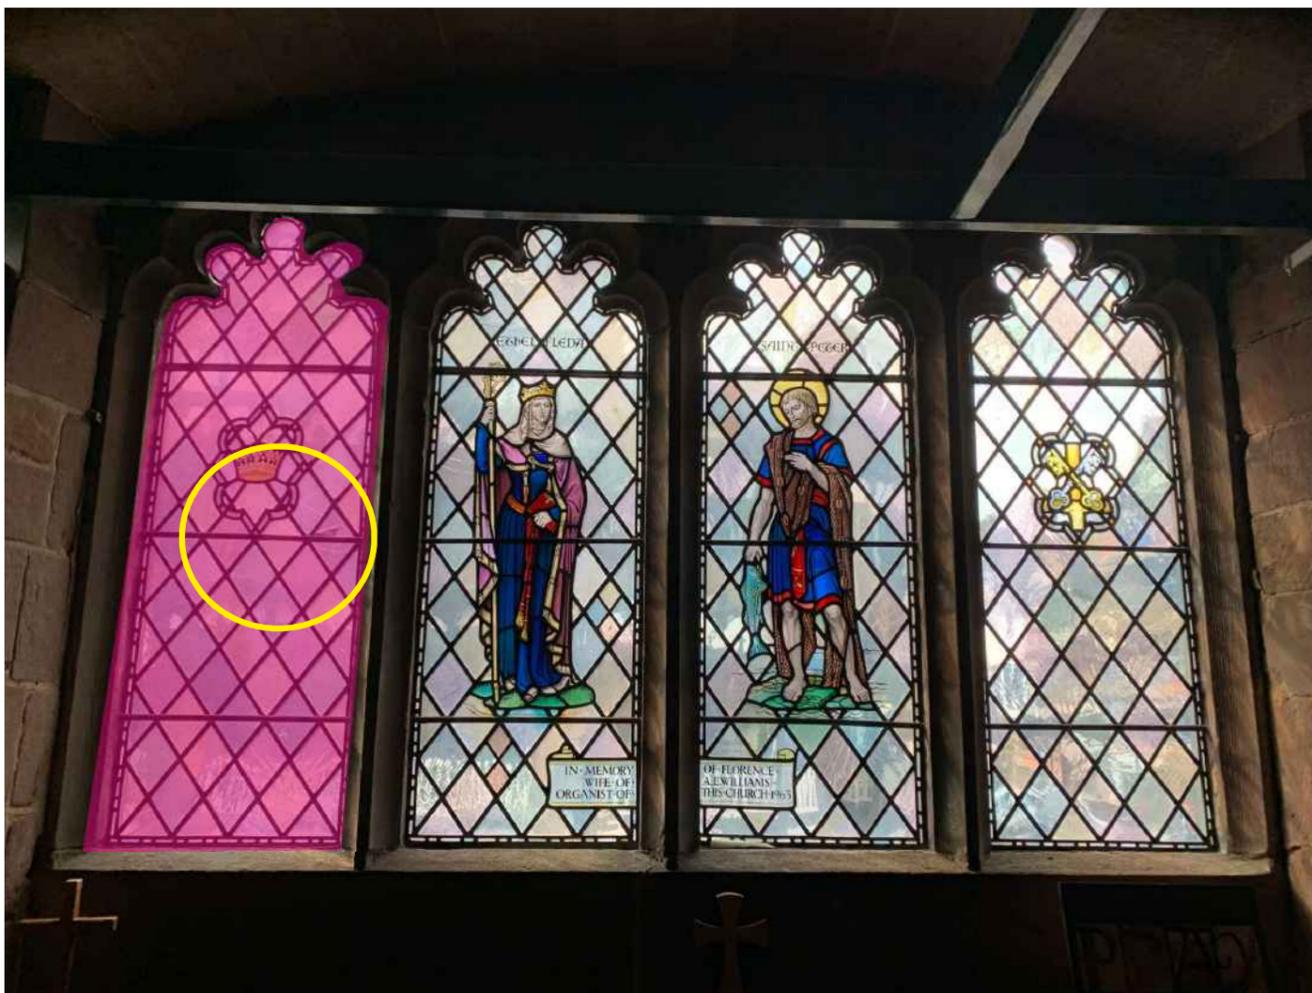
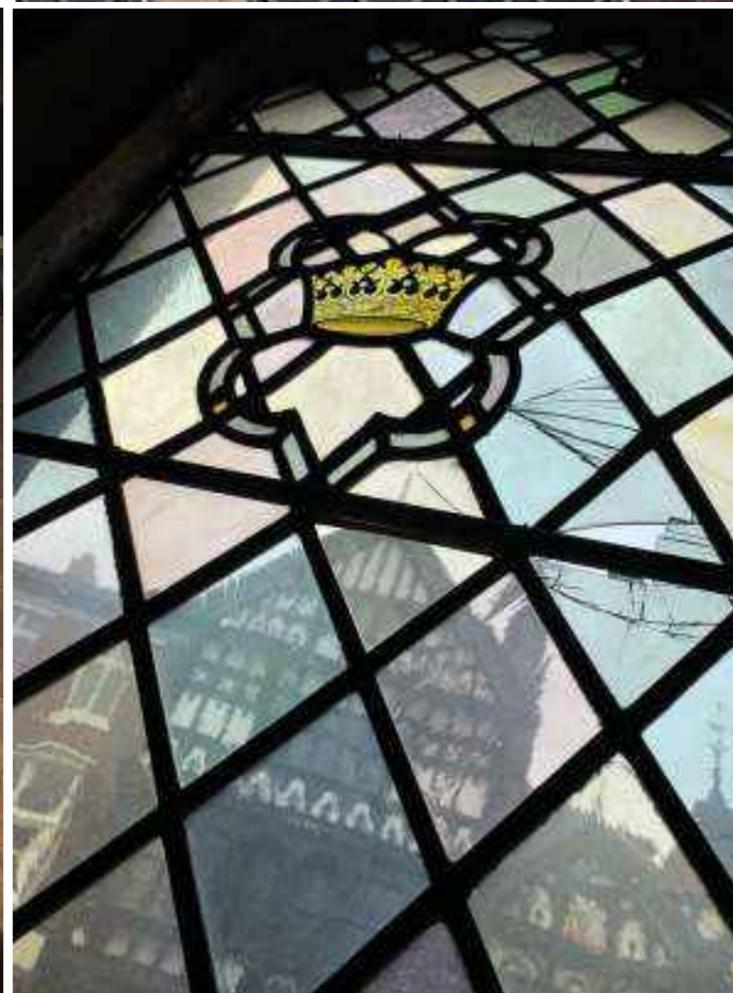
REMOVE & REPAIR LANCET
-

- 1 - External View
- 2 - Internal View
- 3 - Showing damaged leadwork and broken glass
- 4 - Showing damaged leadwork and broken glass

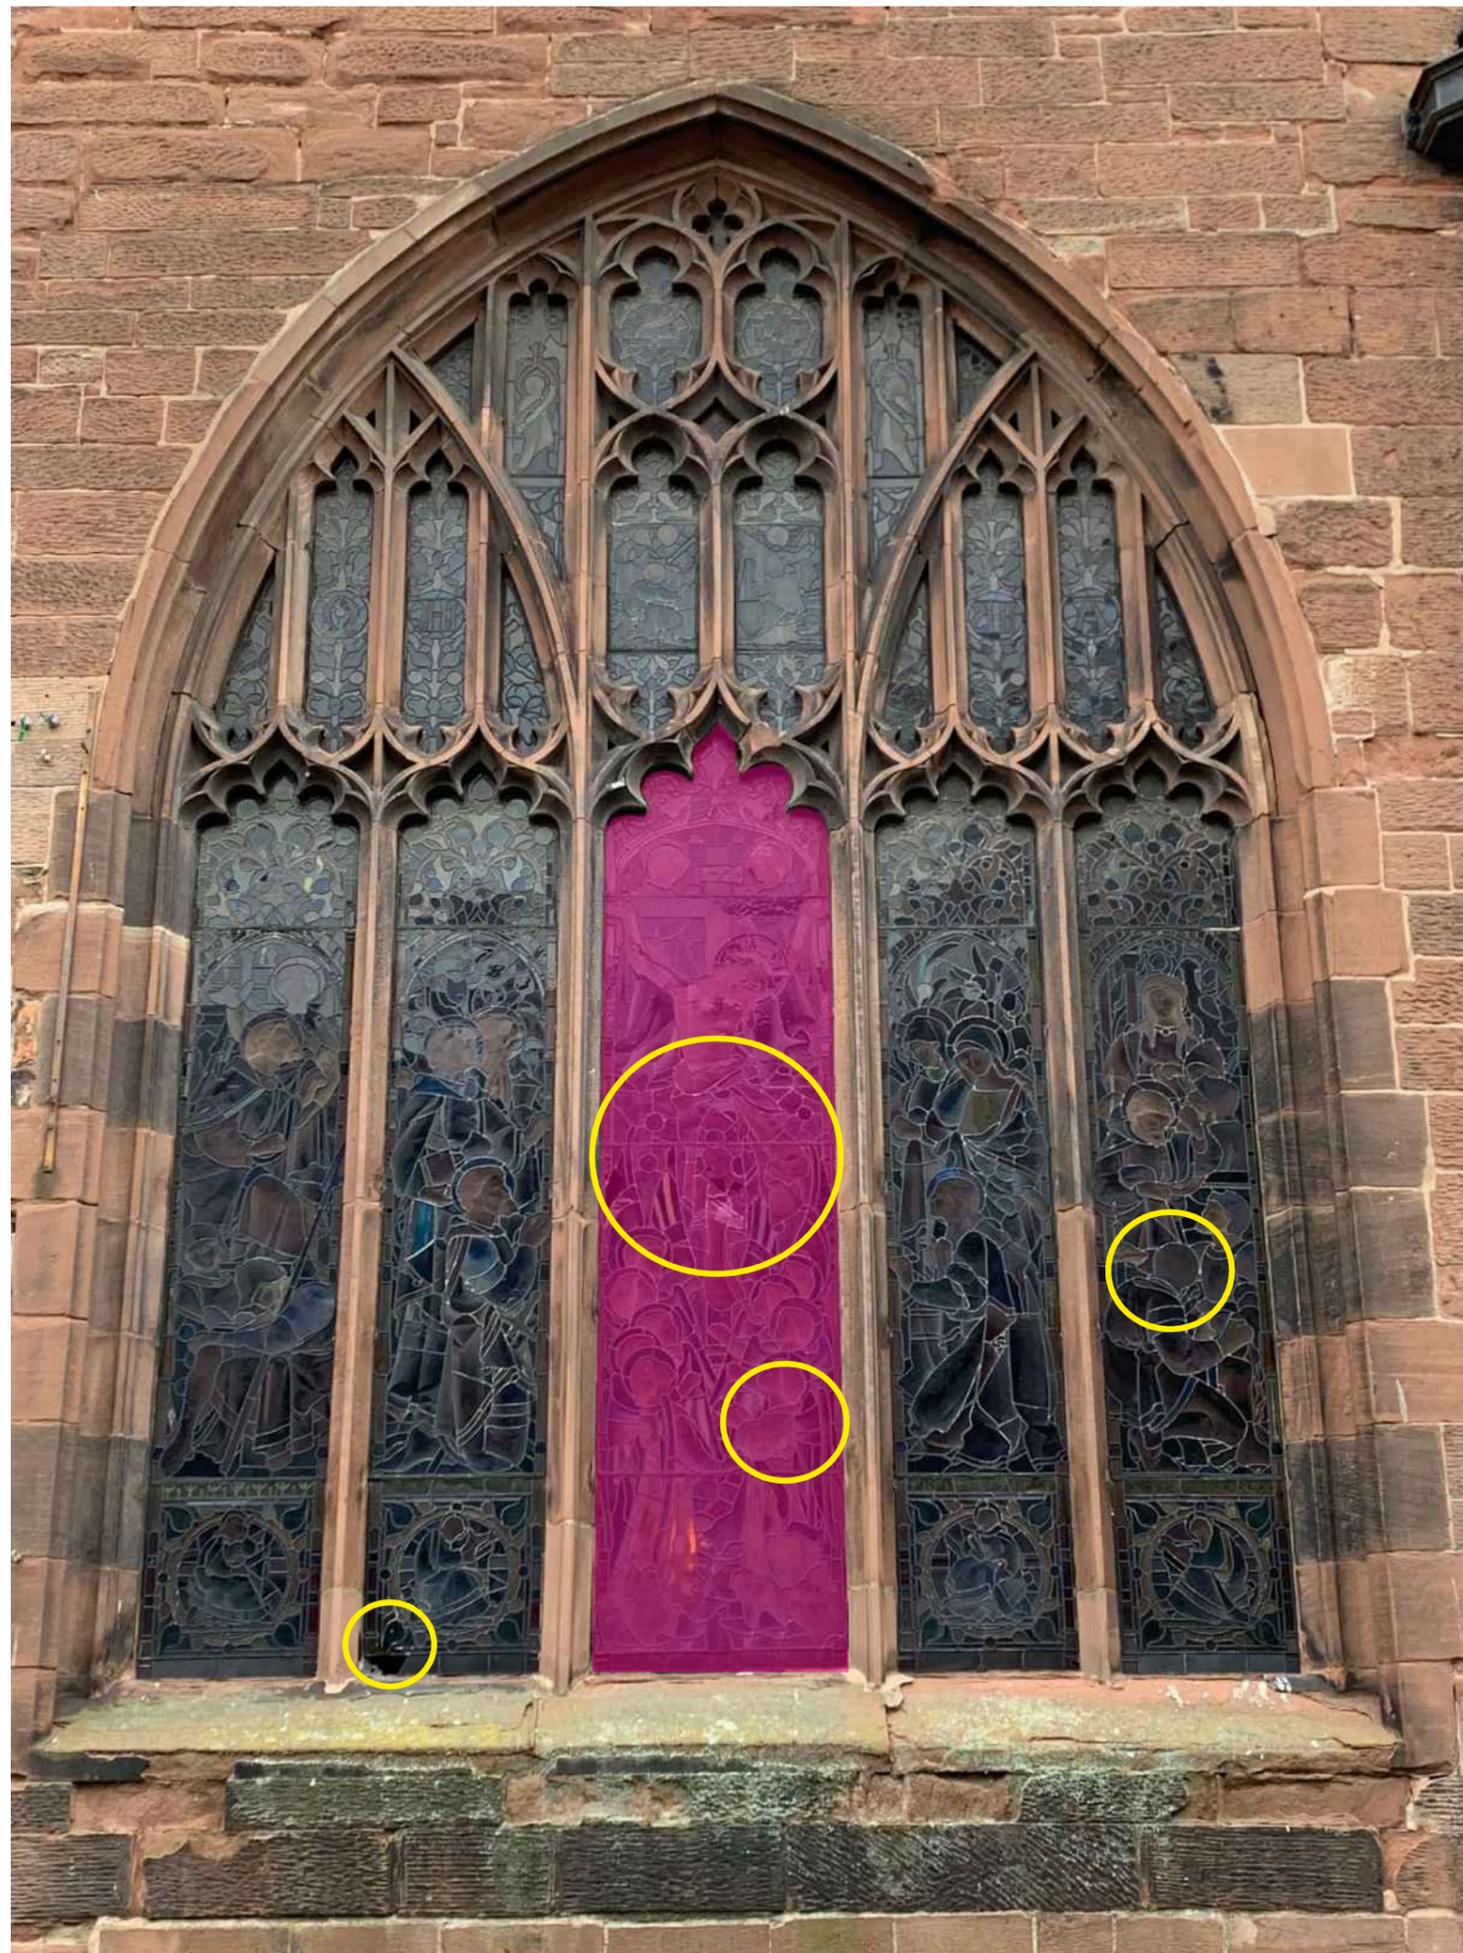
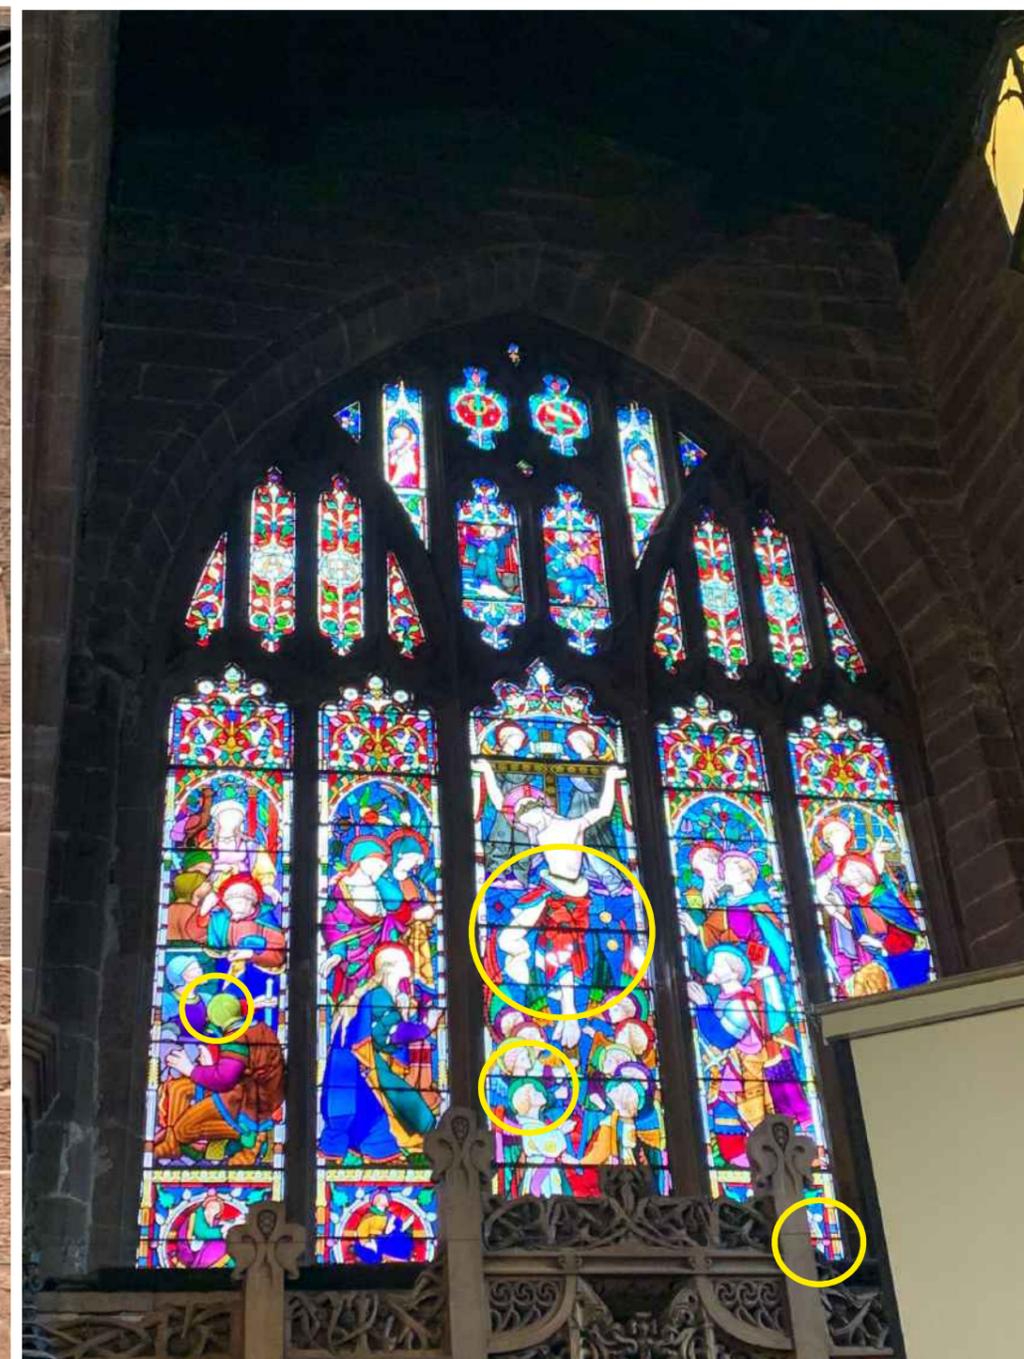
- REMOVE & REPAIR LANCET
- AREAS OF IMPACT

- 1 - External View
- 2 - Internal View
